## THE HAZARDS OF MINE SUBSIDENCE

by Douglas L. Crowell

## Ohio Geology

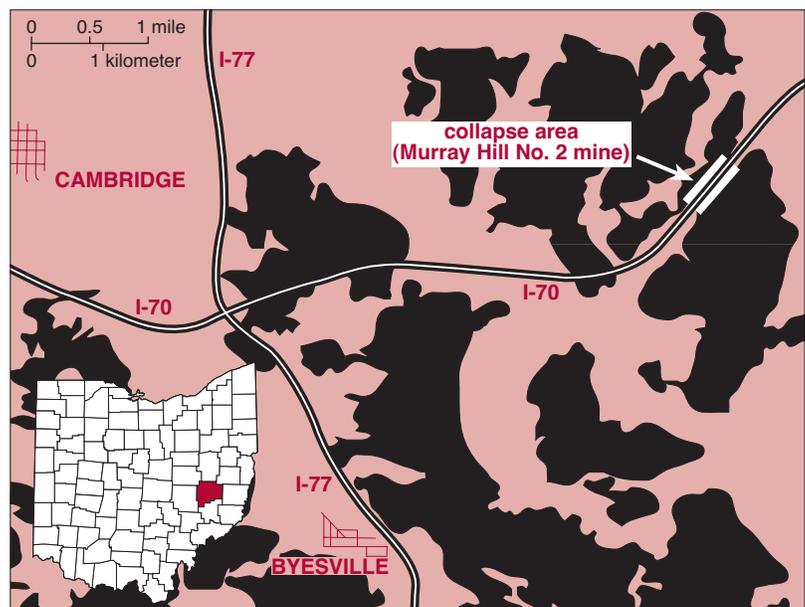
Location of March 1995 mine collapse along I-70 in Guernsey County. Black areas represent known extent of underground coal mines in the region.

The I-70 collapse occurred over a portion of the Murray Hill No. 2 coal mine, located about 4½ miles east of the interchange of I-70 and I-77 in Center Township, Guernsey County. This mine, operated by the Akron Coal Company, was opened in 1912 and abandoned in August 1935. A report by the State Inspector of Mines stated that the Murray Hill No. 2 mine used a slope opening 125 feet in length to mine the Upper Freeport (No. 7) coal, which was 5 to 5½ feet thick. The style of mining was room and pillar, using double main and cross entries developed in a somewhat regular pattern. Many entries were developed at right angles; however, some entries were developed at odd angles, so that some rooms and pillars were quite variable in shape and dimension. Generally, the cross entries are every 440 feet, the rooms are 30 feet wide and up to 400 feet long, breakthroughs are every 60 to 80 feet, and the pillars are 30 feet wide. The State Inspector of Mines stated in a 1913 report that electric coal-cutting machines and motor and mule haulage were used in this mine. Because mules were used for coal haulage, the height of the entries was enlarged by removing some of the roof or floor rock to provide a working height sufficient to accommodate the mules. A 1914 report by the State Inspector of Mines indicates that some miners in the Murray Hill No. 2 mine were involved in pillar work. A common practice in Ohio deep mines, prior to abandonment of a portion of the mine, was to mine the pillars of coal that provide roof support during mining. It is suspected that many pillars in the Murray Hill No. 2 mine had been removed prior to abandonment.

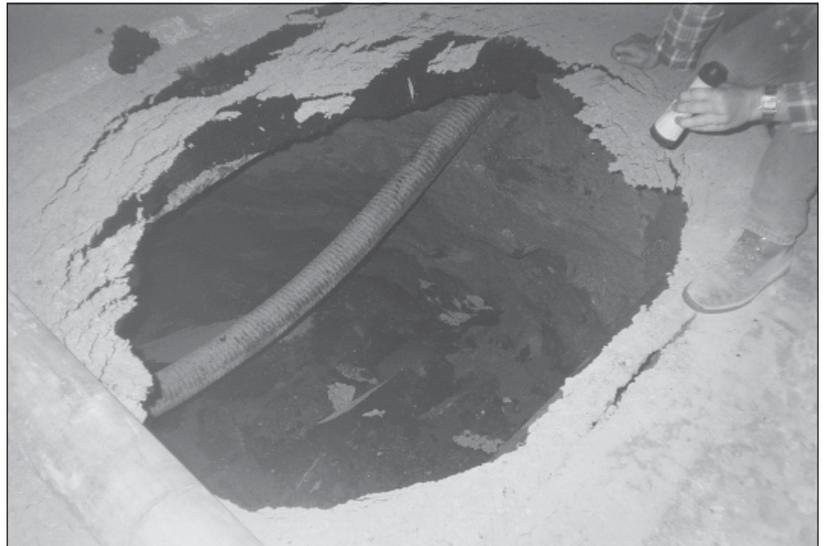
Subsidence pit, about 6 feet in diameter and 8 to 10 feet deep, on I-70 resulting from roof collapse of the Murray Hill No. 2 mine. Photo courtesy of Gannett Fleming, Inc.

There are two types of subsidence: (1) pit (also called sinkhole or pothole) and (2) sag or trough. Pit subsidence is characterized by an abrupt sinking of the surface, resulting in a steep-sided, craterlike feature that has an inward drainage pattern. It is associated with roof collapse of shallow mines, which have cover (overburden) less than 165 feet, incompetent roof rock of shale or mudstone, and a ratio of unconsolidated-material thickness to rock thickness of less than 1.2. Pit subsidence does not occur where the thickness of the unconsolidated overburden is more than 90 feet. Sag subsidence is a gentle, gradual settling of the surface. It is associated with pillar crushing or pillar punching (discussed below) of deeper mines (overburden of more than 75 feet). Sag subsidence features may be water filled where the surface of the subsidence intersects the water table. Subsidence pits generally do not hold water because the pit drains into the underlying mine.

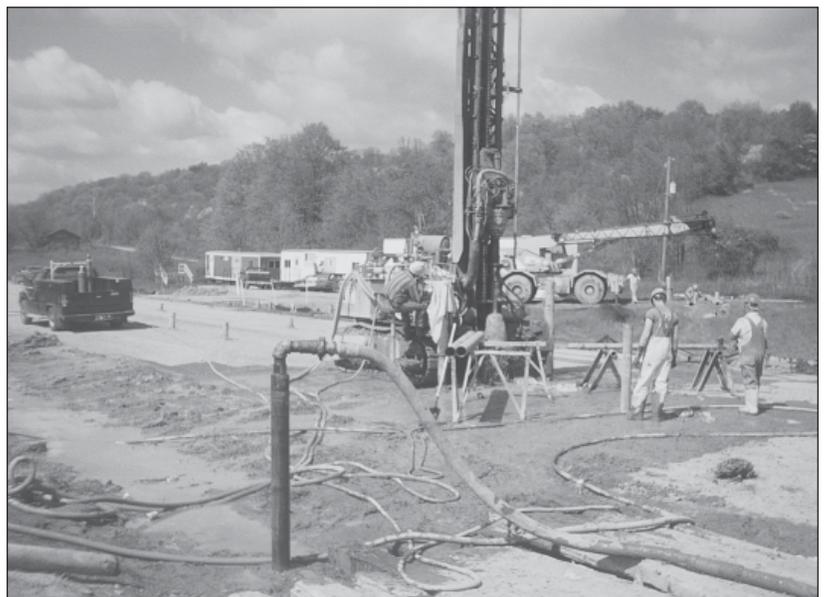
Subsidence stabilization of the westbound lanes of I-70 in Guernsey County. Large-diameter holes were drilled into the Murray Hill No. 2 mine and a mixture of fly ash and cement was pumped into the mine voids to prevent further subsidence. Photo courtesy of Gannett Fleming, Inc.

the subsidence of March 4, 1995, occurred along a quarter-mile stretch of I-70. Stabilization of the subsidence required drilling nearly 2,200 boreholes, averaging 66 feet deep, on approximate 12-foot centers along 1,800 feet of I-70. The top halves of these holes were 8 inches in diameter and drilled to bedrock. The bottom halves of the holes were 6 inches in diameter and drilled into either a pillar of coal or the mined-out area. Following drilling, the mined-out area and the drill holes were filled with 30,385 tons of grout (18,740 tons of fly ash and 11,645 tons of cement, sand, and gravel). In addition, two reinforced-concrete land bridges, 110 feet and 700 feet long, respectively, were constructed on the westbound lanes of I-70 to protect the highway from subsidence due to collapse voids in the unconsolidated material underlying the westbound lanes. These collapse voids are a result of mine-roof col-

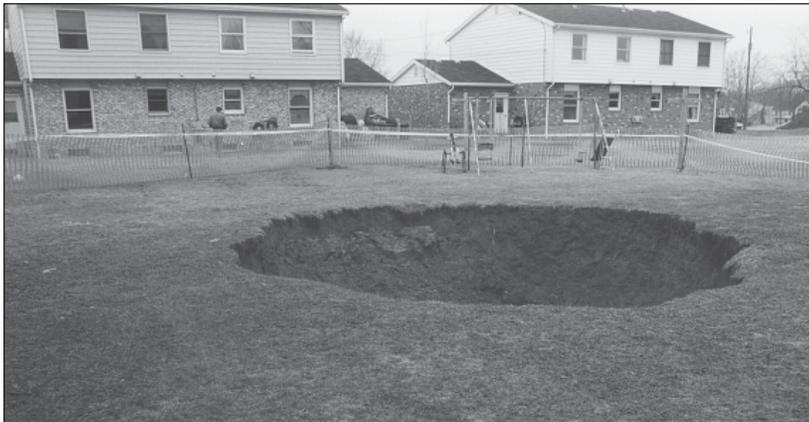
Subsidence pit behind a residence in North Canton, Stark County. This pit was 35 feet in diameter and 25 feet deep. Photo courtesy of Ohio Division of Mines and Reclamation.

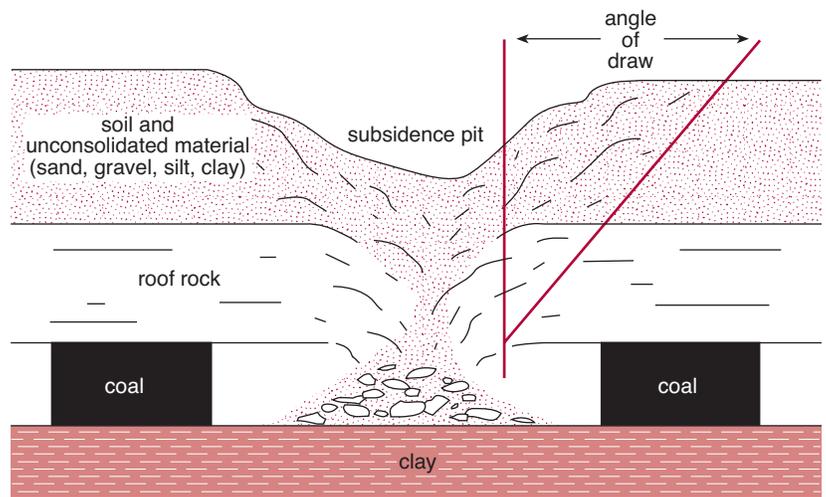
Diagrammatic cross section of typical subsidence resulting from mine-roof collapse. No scale implied.

Subsidence, in the context of underground mining, is the lowering of the Earth's surface due to collapse of bedrock and unconsolidated materials (sand, gravel, silt, and clay) into underground mined areas. Ohio has had a history of mine subsidence problems dating to at least 1923. Subsidence can cause structural damage to buildings, highways, sidewalks, and curbing and disrupt gas, water, and sewer lines and water wells.

The area of mine subsidence increases proportionally with increasing width of unsupported roof rock. The potential area of subsidence is equal to the extraction area plus an area surrounding the extraction area measured by an angle up to 35°, called the angle of draw, taken from the vertical at the edge of the extraction area. For example, roof collapse in a mine 160 feet deep could cause subsidence more than 75 feet beyond the edge of the mine. The deeper the mine, the larger the area potentially affected by mine subsidence at the surface.

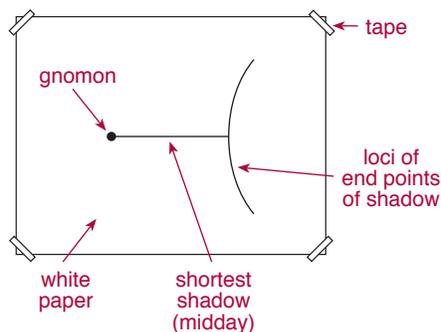
*Bird's-eye view of set up for determining midday.*

Take the class outside on a sunny day about a half hour before your calculated value of midday. They will need a horizontal surface, such as a sidewalk, on which to work. Place the support stand on the level surface and arrange the large sheet of paper so that the shadow of the tip of the rod falls on the paper. Tape the paper to the level surface. (Remember, the shadow is going to move; that is why we have an extra sheet of paper.) The position of the base of the stand should be outlined by pencil on the paper so that if the stand gets bumped, it can be returned to its original position.

Students should begin their measurements at least 20 minutes before the calculated value for midday and should measure the length of the shadow every 2 minutes for approximately 40 minutes. They should mark the position of the tip of the rod's shadow and note the time beside each mark. Measurements should continue until the length of the shadow begins to noticeably increase. Midday is when the length of the rod's shadow is shortest. A line drawn on the paper between the mark representing the

tip of the minimum shadow and the center of the base of the support rod provides a true north-south line.
